F. EXAMPLE PROJECTS WHICH BEST ILLUSTRATE PROPOSED TEAM'S QUALIFICATIONS FOR THIS CONTRACT <i>(Present as many projects as requested by the agency, or 10 projects, if not specified. (COMPLETE ONE SECTION F FOR EACH PROJECT.)</i>		20. EXAMPLE PROJECT KEY NUMBER	
21. TITLE AND LOCATION (CITY AND STATE) Swinging Bridge Penstock Remediation Sullivan County, New York		22. YEAR COMPLETED PROFESSIONAL SERVICES 1994 – 2001 CONSTRUCTION (IF APPLICABLE) 1995	
23. PROJECT OWNER'S INFORMATION			
a. PROJECT SPONSOR Orange & Rockland Utilities, Inc.	b. POINT OF CONTACT NAME John Haggarty	c. POINT OF CONTACT TELEPHONE NUMBER (845) 577-3700

24. BRIEF DESCRIPTION OF PROJECT AND RELEVANCE TO THIS CONTRACT (Include scope, size, and cost)

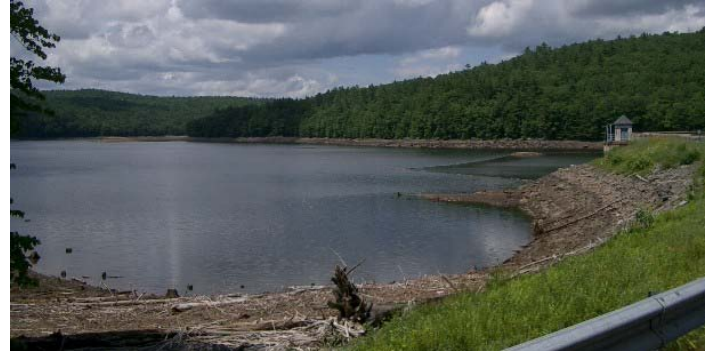
Swinging Bridge Dam is a component of the Mongaup River Basin Hydro Project in Sullivan County, New York (FERC Project No. 10482-NY). This earthen embankment Dam was constructed in 1927 using semi-hydraulic fill construction techniques. The Dam spans across the Mongaup River and is equipped with two hydroelectric generating units. A 14-foot wide concrete Tunnel Structure runs the entire cross-section of the Dam and includes a 10-foot diameter steel-lined Penstock and a 9-foot square access tunnel. Leakage into the access tunnel and a rupture in the Penstock liner was noted during an annual FERC inspection. RIZZO was retained by Orange and Rockland Utilities, Inc. (ORU) to perform settlement and buckling analyses of the Penstock, and static and dynamic stability analyses for the Dam.

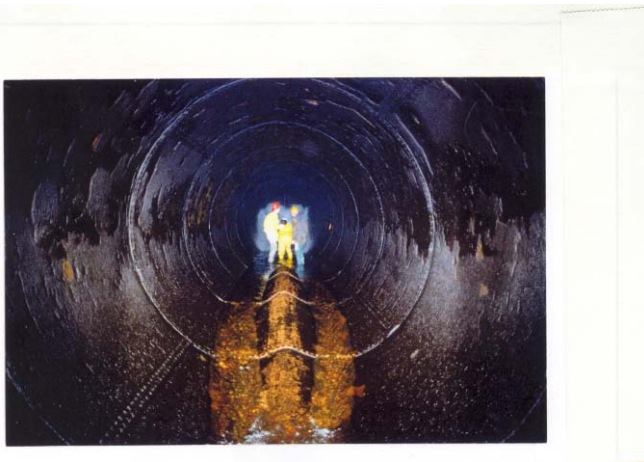
A FERC approved work plan for field investigation was implemented by RIZZO including drilling of borings, and installation of piezometers for monitoring seepage through the Dam. SPTs were recorded and undisturbed thin-wall tube samples were recovered for laboratory testing. Settlement analyses of the tunnel structure calibrated the analytical model with respect to recorded settlements in 1930.

The model was utilized in estimating deformations, bending moments, and shear forces and stresses in the Penstock liner for use in the buckling analyses.
